DEPARTMENT OF TRANSPORTATION

Contract #: 04-0120F4Cty: SF/ALA Rte: 80 PM: 13.2/13.9File #: 99.28**WELDING INSPECTION REPORT****Resident Engineer:**Siegenthaler, Peter**Address:** 333 Burma Road**City:** Oakland, CA 94607**Report No:** WIR-021001**Date Inspected:** 19-Feb-2011**Project Name:** SAS Superstructure**OSM Arrival Time:** 700**Prime Contractor:** American Bridge/Fluor Enterprises, a JV**OSM Departure Time:** 1900**Contractor:** Zhenhua Port Machinery Company, Ltd (ZPMC) Chanxing Island**Location:** Shanghai, China**CWI Name:** Mr. Qui Wen**CWI Present:** Yes No**Inspected CWI report:** Yes No N/A**Rod Oven in Use:** Yes No N/A**Electrode to specification:** Yes No N/A**Weld Procedures Followed:** Yes No N/A**Qualified Welders:** Yes No N/A**Verified Joint Fit-up:** Yes No N/A**Approved Drawings:** Yes No N/A**Approved WPS:** Yes No N/A**Delayed / Cancelled:** Yes No N/A**Bridge No:** 34-0006**Component:** OBG Segment**Summary of Items Observed:**

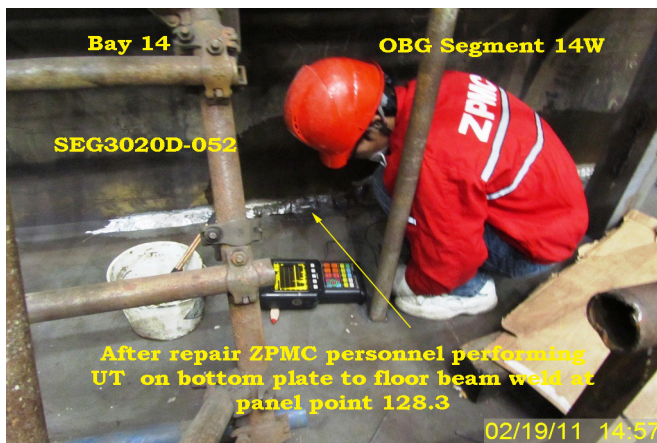
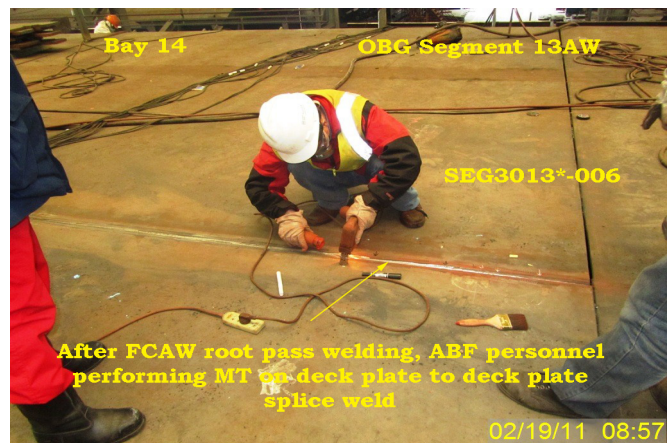
This QA inspector observed ZPMC personnel performed Ultrasonic Testing on OBG Segment 14W located on floor beam to bottom plate 'T' joint weld. The weld number is identified as SEG3020D-052 and SEG3020E-056. See the attached pictures.
